**North West Wales Dendrochronology Project  
Blaen Glasgwm Uchaf, Penmachno,  
Gwynedd  
NPRN 26032**

**EAS Client Report 2012/05  
July 20121**

**North West Wales Dendrochronology Project  
Blaen Glasgwm, Penmachno,  
Gwynedd  
NPRN 26032**

**By  
I.P. Brooks**

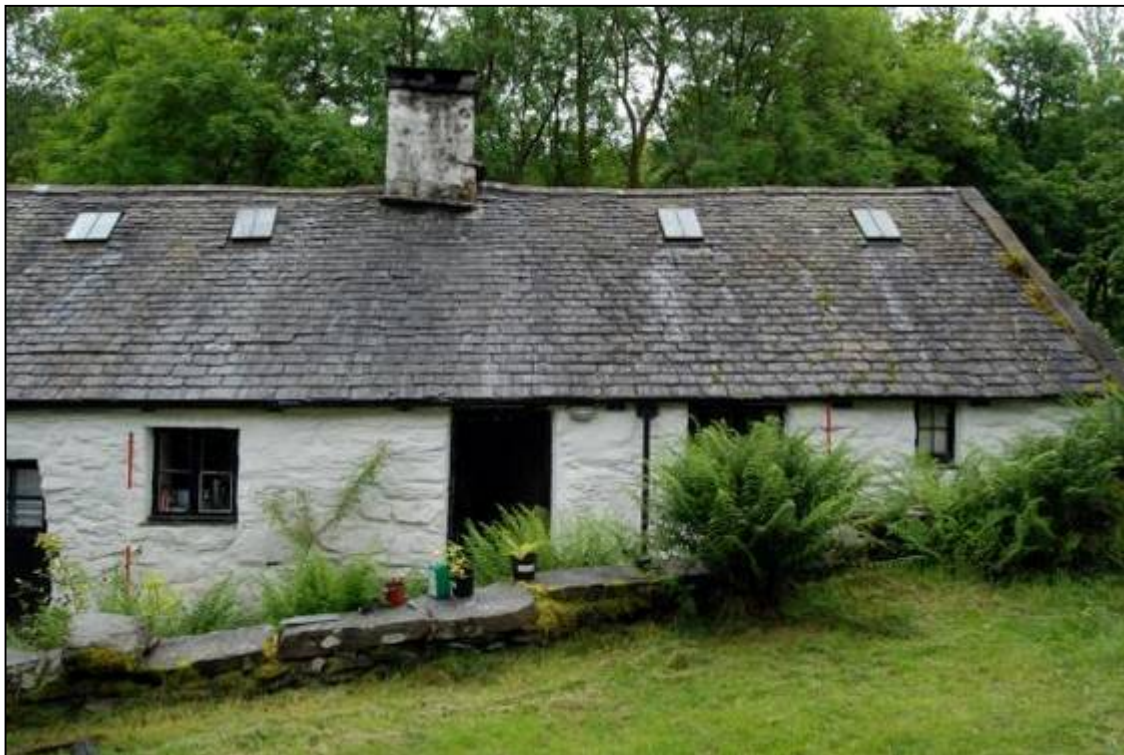
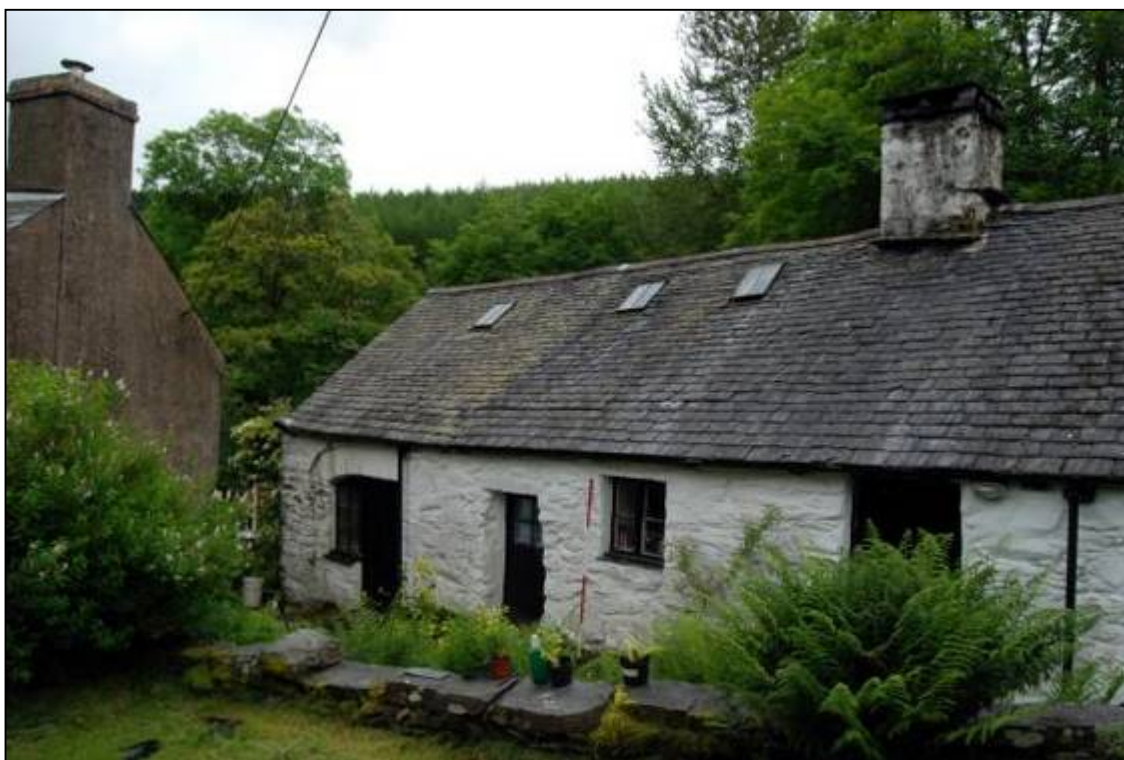
Plate 1: Front elevation, western end

Plate 2: Front elevation, eastern end

The front elevation has three windows and two doorways (Plates 1 and 2). The central door is a later insertion replacing a doorway further to the west which is now occupied by one of the windows (Plate 8). Whilst the two eastern windows are of a size with four pane casement windows, the western window is much smaller and it may represent the original size of the windows for this house. The rear elevation (Plate 3 and 4) has three window openings, the two eastern openings having four pane windows, whilst the western window is smaller and has only recently been revealed (A. Brown *pers. comm.*). The scar at the base of the rear elevation marks the position of a leat which supplied water to the water wheel on the later, agricultural extension.

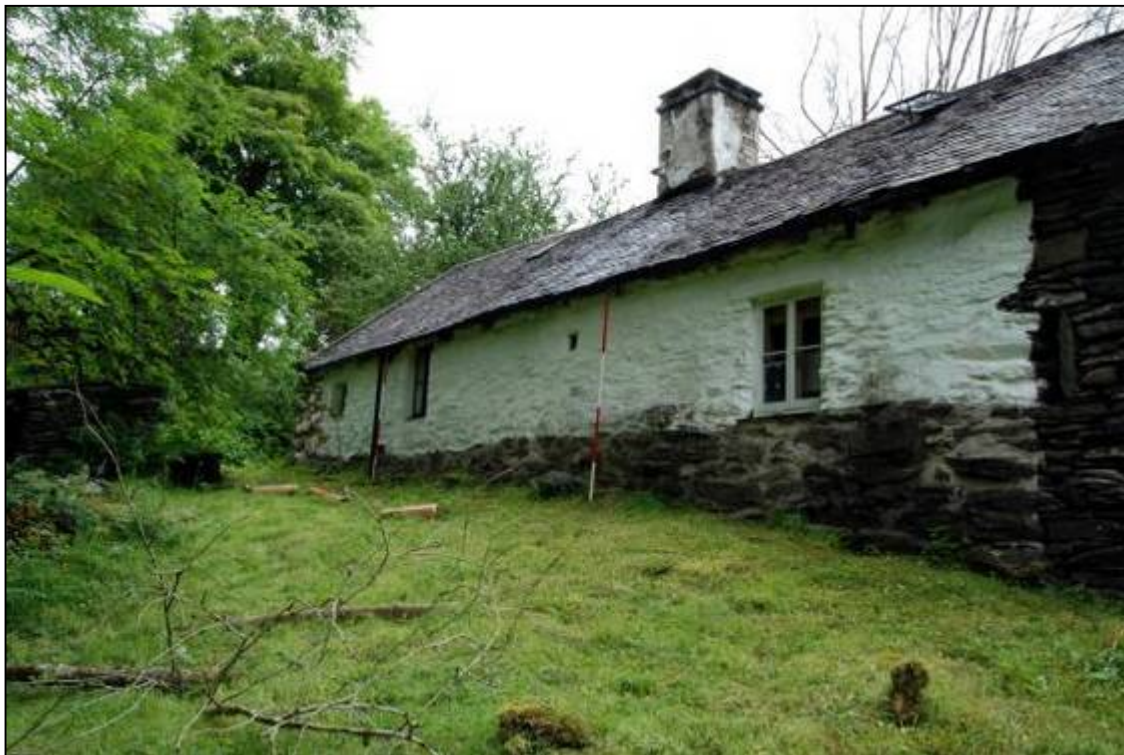
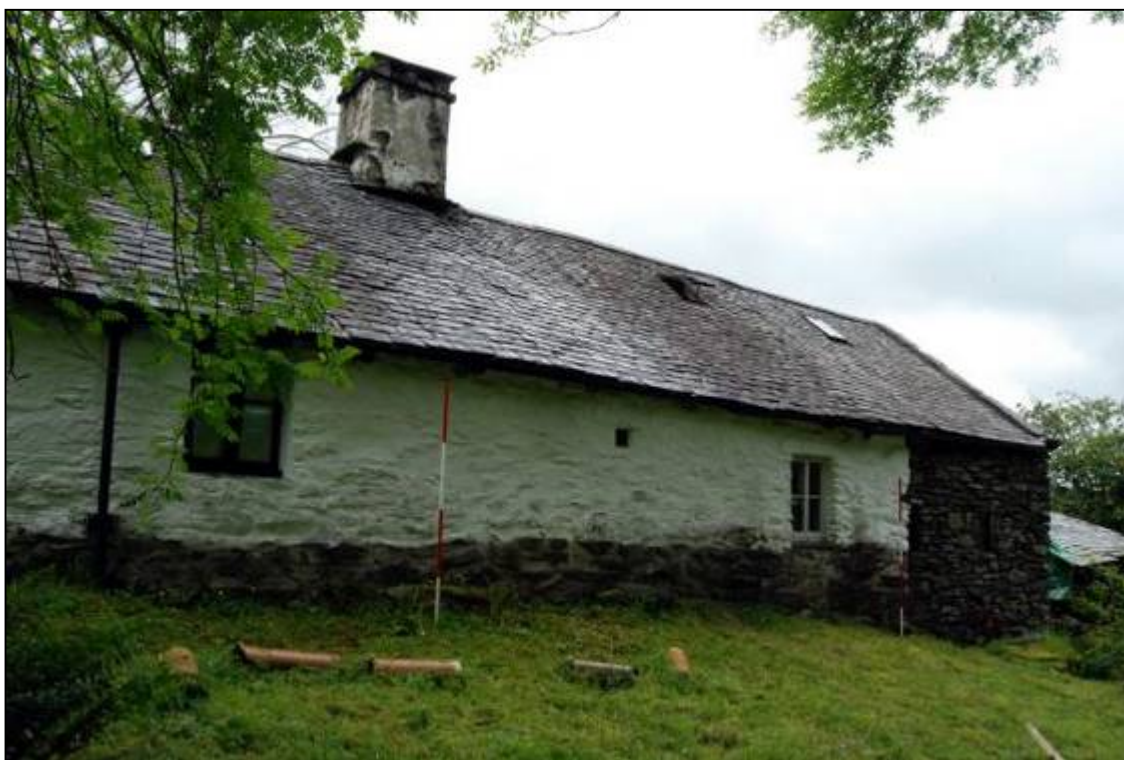
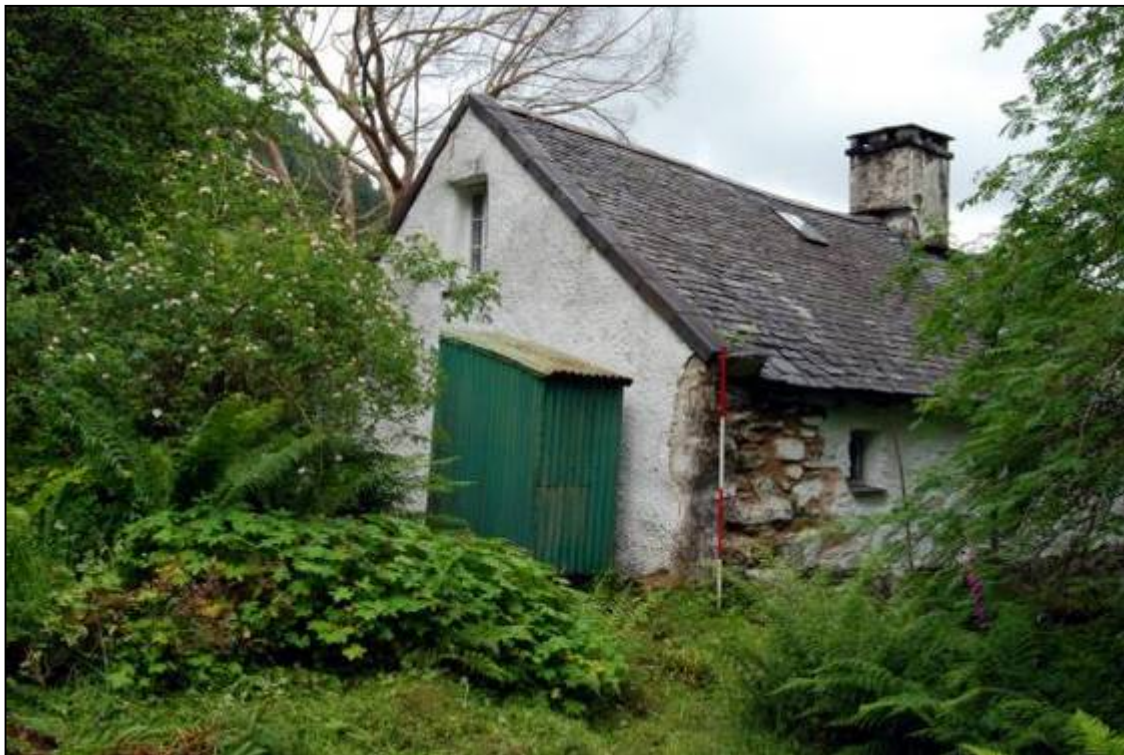
Plate 3: Rear elevation, looking NW

Plate 4: Rear elevation looking NE

Plate 5: Western gable end

The house is a lofted, single storey building built of random stonework which has been lime washed (Plates 1 – 5). In places the large boulder footings are exposed, particularly on the front elevation. The eastern end of the range is a later extension which has been largely re-built in recent years (A. Brown *pers comm.*). This was a later, agricultural extension which had a large doorway with a slightly cambered voussoirs opening (Plate 6) and the remains of an iron drive wheel on its rear elevation (Plate 7). The larger opening has been partly filled with a single door and a six pane casement window. Both ranges are covered by a single gabled roof with small slates, “V” shaped ridge tiles, a series of sky lights and gable copings at the eastern end. There is a single chimney with tabling and

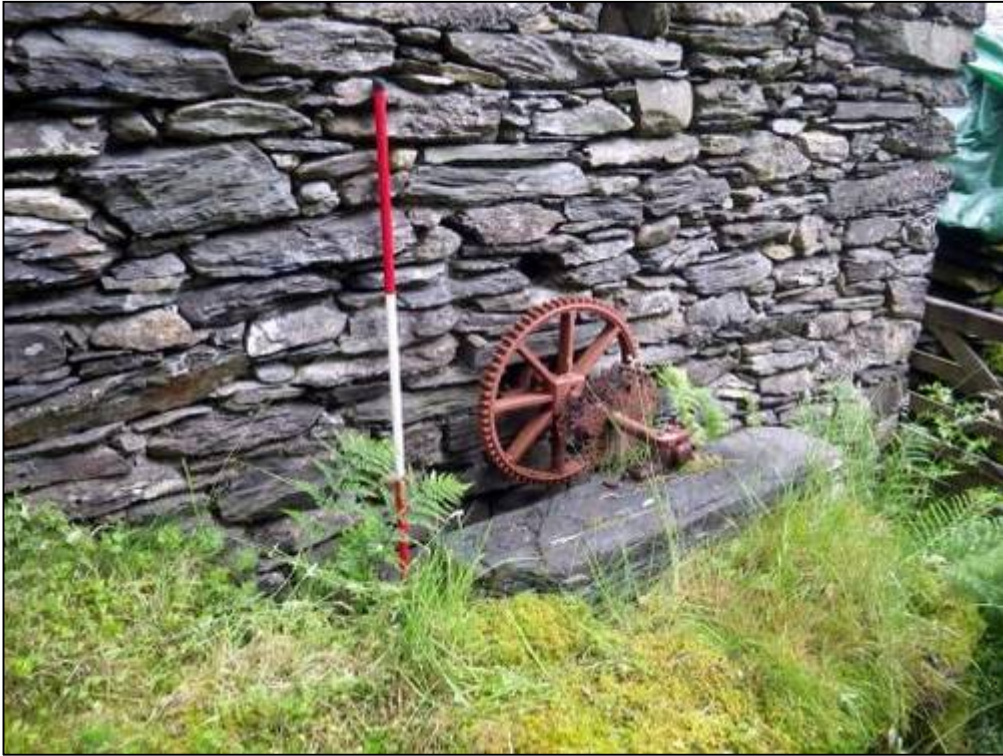
Plate 7: Iron drive wheel on rear elevation of the eastern extension

Late in the development of the building the small agricultural range was added to the eastern end of the house. At some stage, probably in the nineteenth or early twentieth century a water wheel was added together with a leat along the rear elevation of the house. It is not known what this wheel drove.

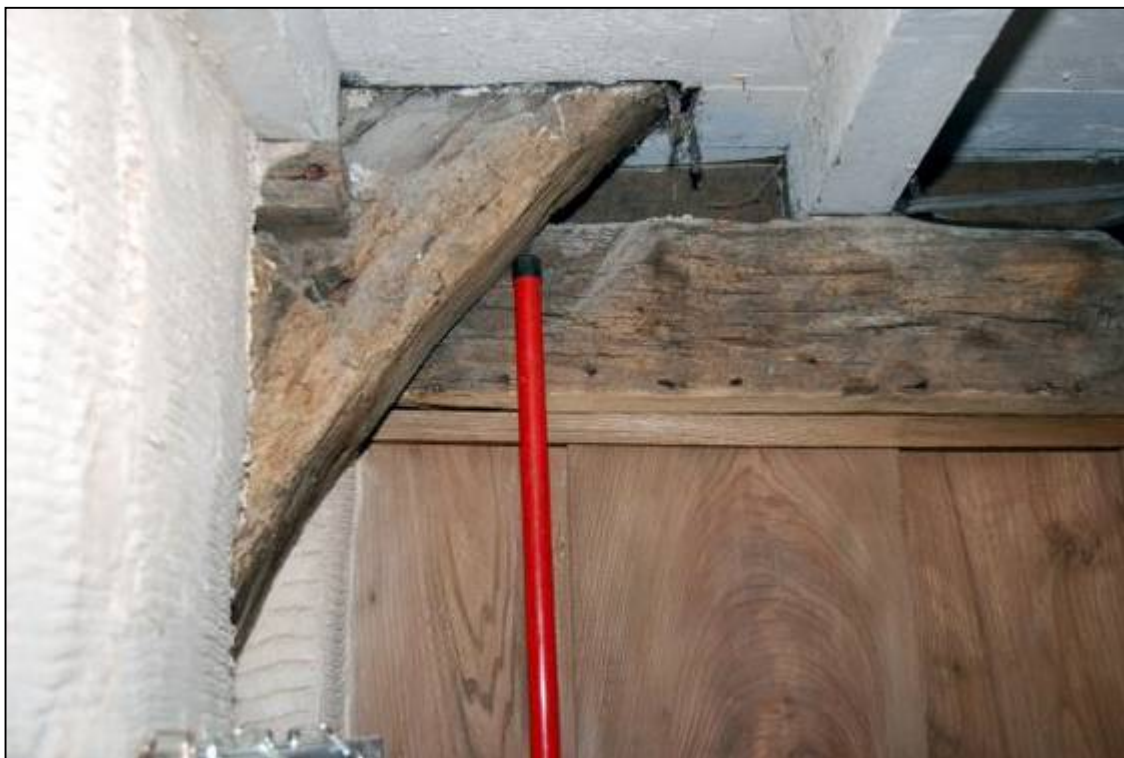
Plate 10: Base of the southern principal rafter of Truss 1, looking west

Internally the house is divided into two main rooms (Figure 3), on either side of the central chimney, linked by a lobby. This space appears to be a later feature relating to the moving of the main door to the east. The eastern room has been sub-divided with a relatively modern, wooden partition. This is below a beam which appears to be earlier, possibly suggesting that there was a partition at this point at an earlier period. Another possibility is that this beam was added to support a crog loft at this end of the building. The beam has a single mortice cut into its upper surface (Plate 9) potentially suggesting the level of a previous ceiling. The lower parts of principal rafters of Truss 1 are exposed, at this level, adjacent to the partition (Plates 10 and 11) and would appear extend within the stone walls of the cottage.

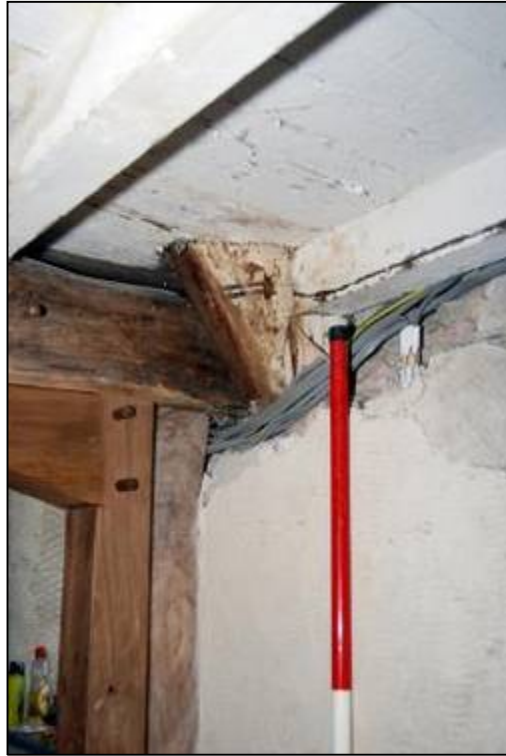
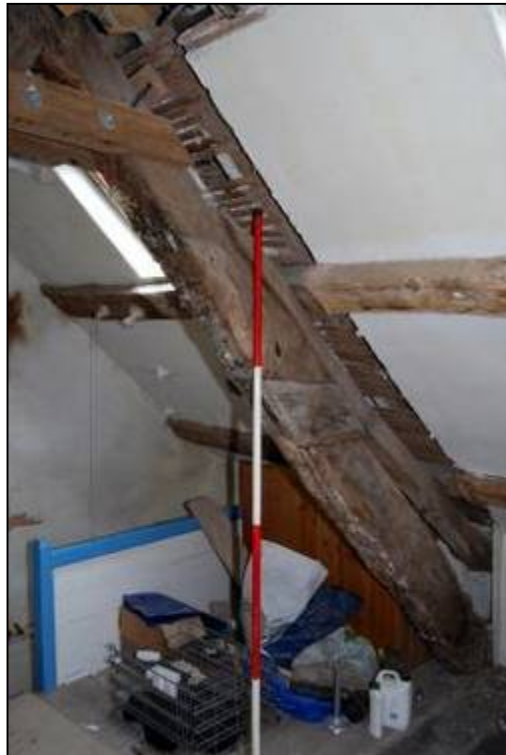
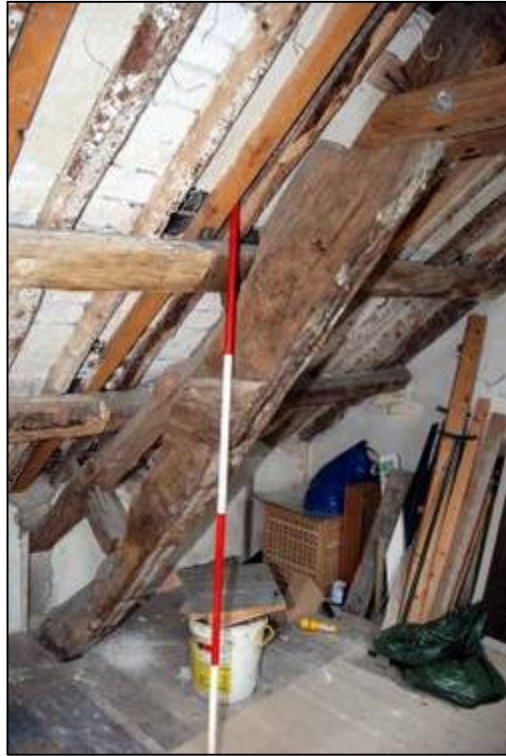
Plate 11: Base of northern principal rafter of Truss 1, looking NW

Plate 13: The northern principal rafter of Truss 1

Plate 15: The southern principal rafter of Truss 1

The bulk of Truss 1 is exposed in the attic above (Figure 5, Plates 11, 13 and 15). This is a cruck frame of Alcock type E (Alcock 1981, 95) with the blade jointed together diagonally and the socket for a ridge purlin (Plate 12). The current ridge piece is a round timber which appears to relate to a later roof structure. There was a collar on this truss which has been cut, leaving the stubs of the timber still in place. (Plates 13 – 16) This timber was held in place with a halved lap joint which had two pegs driven through each of the joints (Plate 14, 16 - 18). There are a series of peg holes driven through the width of the cruck blades which mark the original position of the purlins associated with this truss. The upper purlins sat within slight trenches whilst the lower purlins would appear to have sat directly on the principal rafters. There is a burn mark on the northern principal rafter which is assumed to be the result of a candle being placed near to the truss (Plate 19). There is also a large iron nail on each of the principal rafters, above the level of the collar, the function of which is unknown (Plate 20).

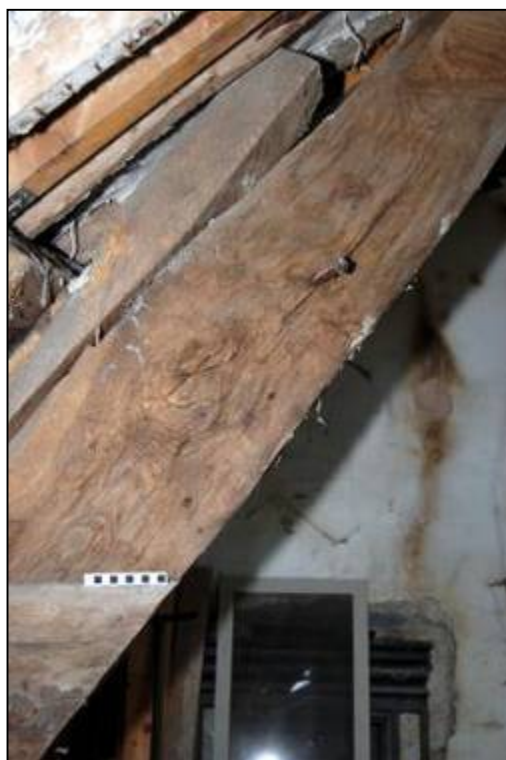
Plate 20: Iron nail on southern principal rafter of Truss 1

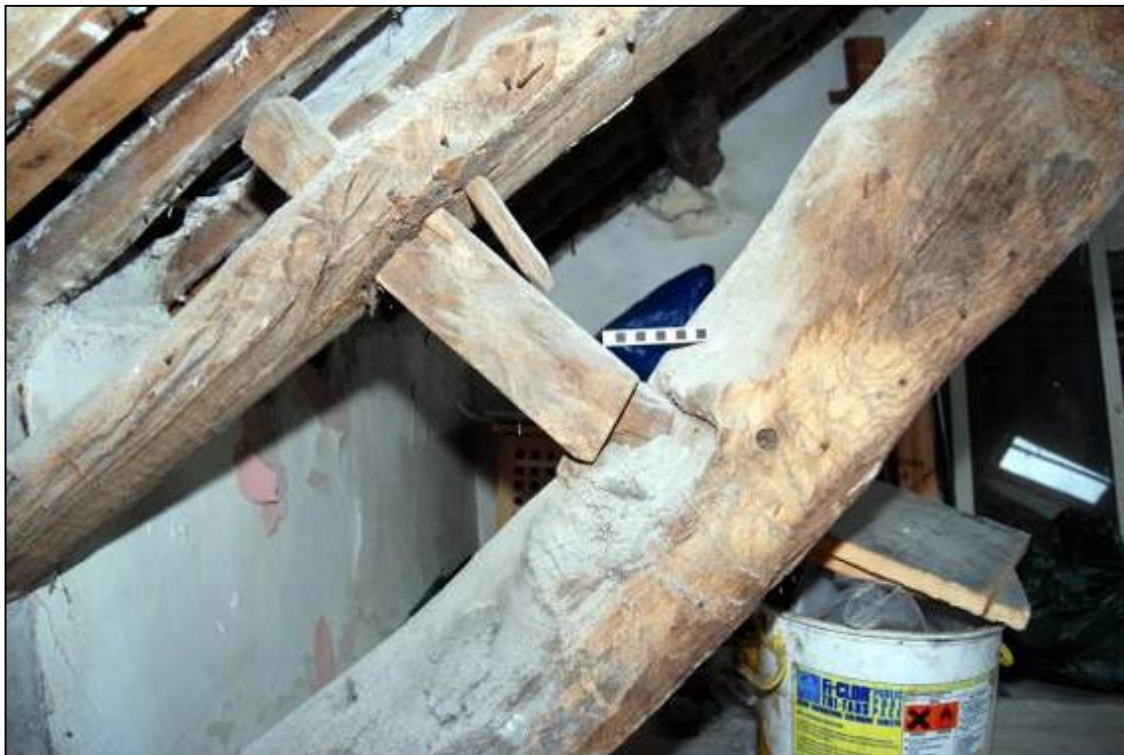
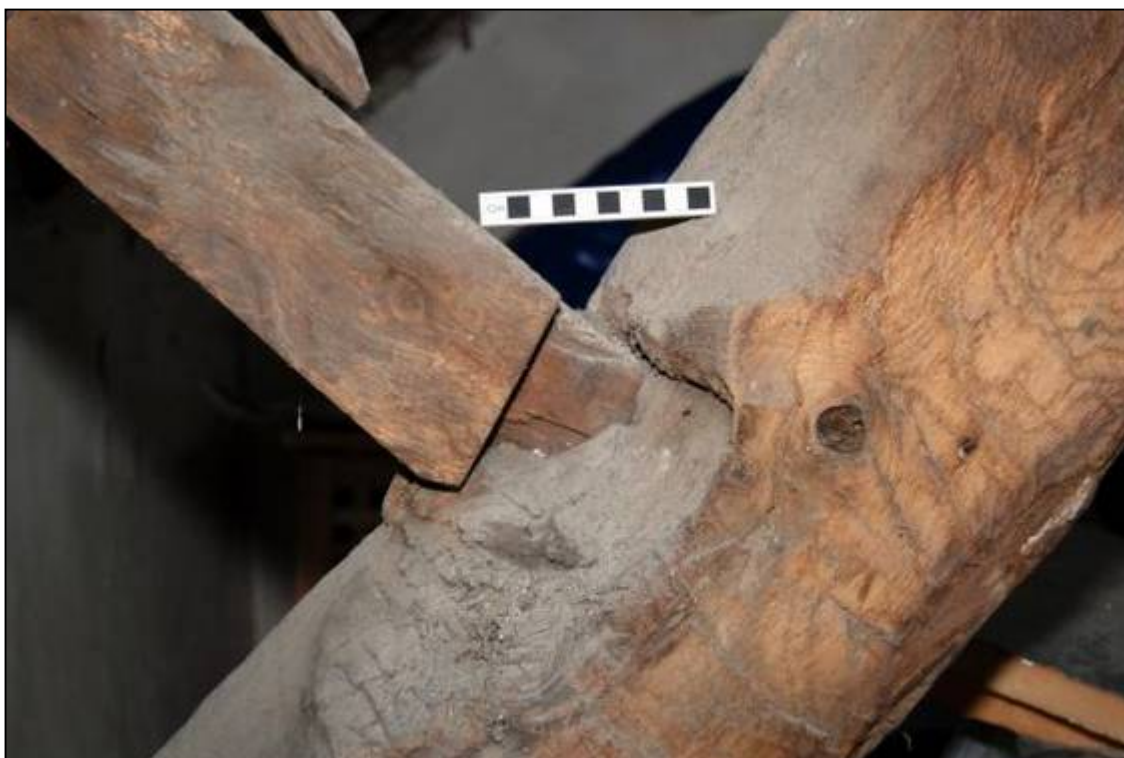
Plate 21: Support for the secondary rafter on the southern side of Truss 1

Plate 22: Detail of the joint between the southern principal rafter and the support for the secondary rafter of Truss 1

The angle of the roof has been reduced at some point in its history with addition of secondary rafters. On the northern side of the roof this was achieved by resting the secondary rafter on the cruck blade and the top of the stone wall on the north side of the building. On the southern side, however, short timber was used to support the secondary rafter with mortice and tenon joint to both the principal rafter and the secondary rafter (Plates 21 and 22). The purlins sit on top of the

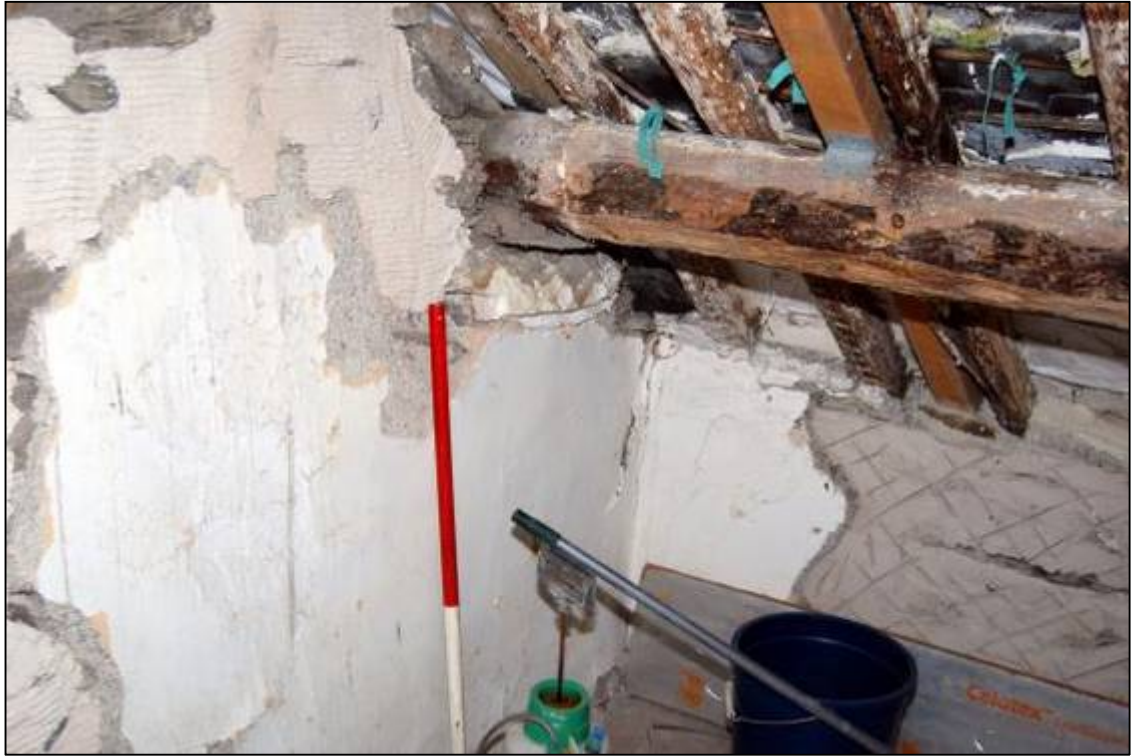
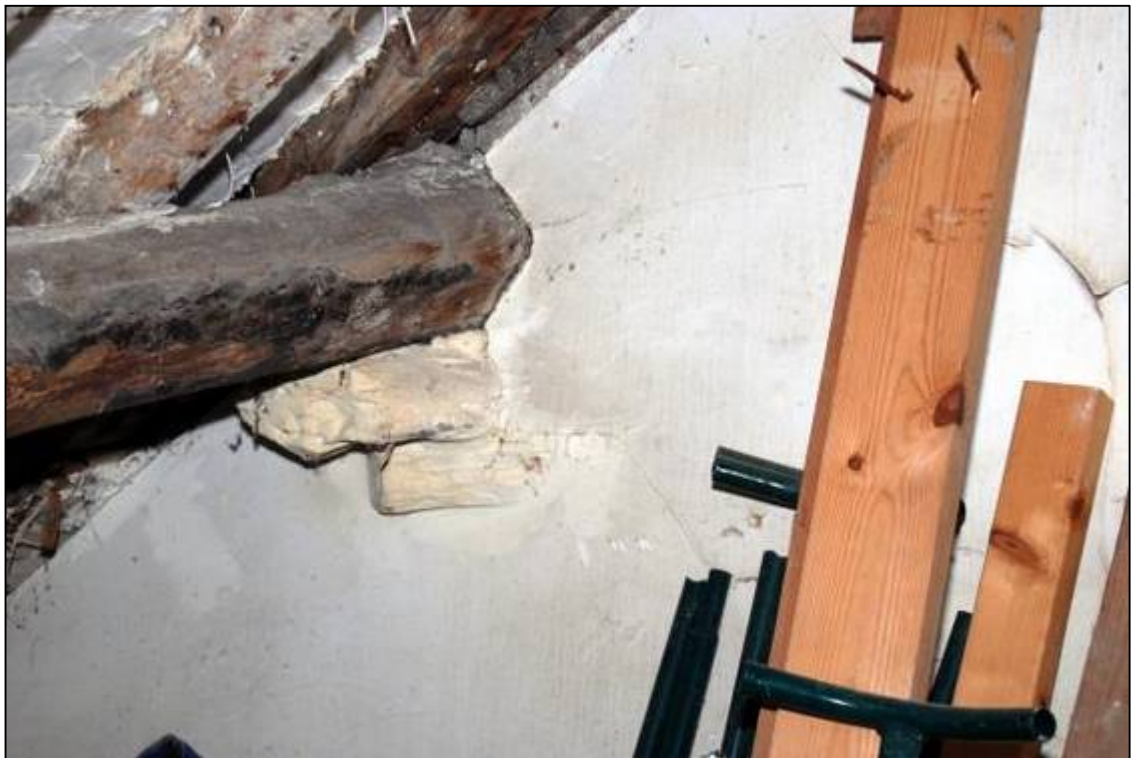
Plate 23: Rough corbel supporting the western end of the northern lower purlin

Plate 24: Rough corbel supporting the eastern end of the northern lower purlin

secondary rafters, three of which are supported by cleats. The lower northern purlin is also supported at each end of the room by rough stone corbels (Plates 23 and 24)

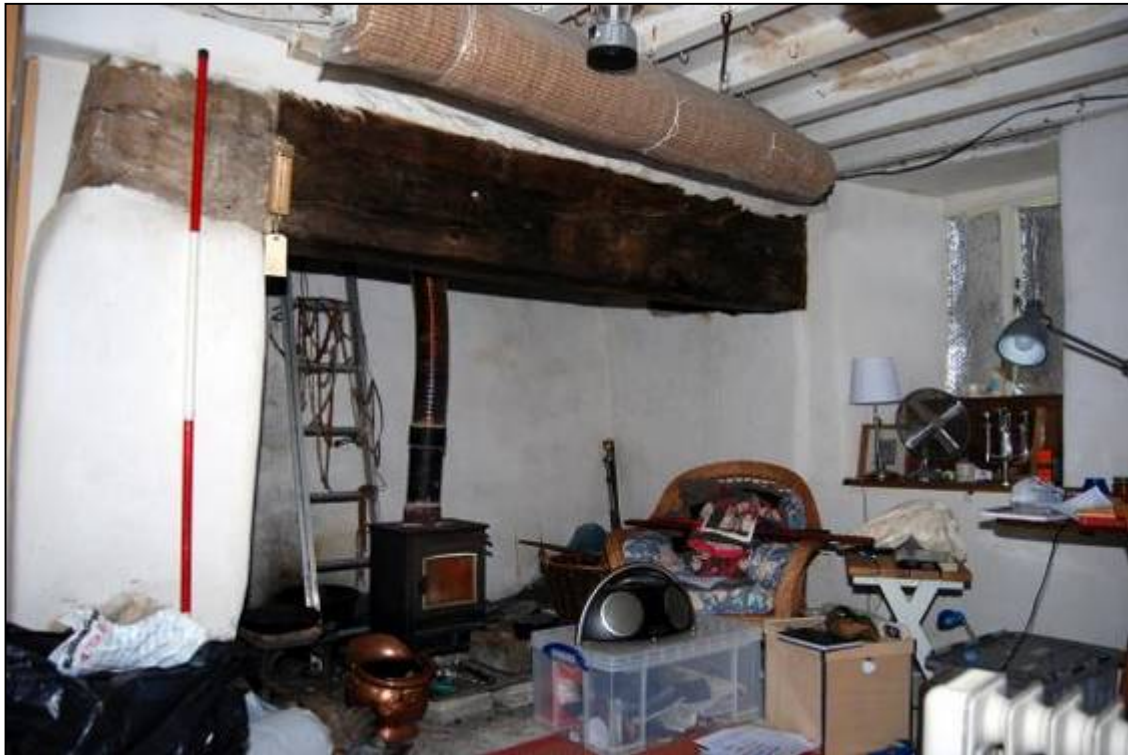
Plate 25: The fireplace

The lower western room is dominated by the inglenook fireplace under large straight bressumer (Plate 25). This bressumer is 430 mm deep and up to 350 mm thick although it is thinner along its lower edge (170 mm) with all of the tapering occurring on the back face of the bressumer (Figure 7). In the south western corner of the room is a recently revealed window (Plate 26, Figure 7). This has the remains of a wooden frame, the top rail of which appear to extend into the wall possibly suggesting the presence of an earlier timber frame. The window frame has a series of mortice holes suggesting the presence of central mullion and two vertical bars (Plate 27). The lower portions of Truss 2 extend into this room with the lower section of the cruck blades partly embedded in the walls (Plates 28 – 31). When these blades were exposed in the restoration work the sockets for lateral rails was noted suggesting the building may have originally been timber framed (A. Brown *pers. comm.*). The northern blade would appear to have been modified (Plate 29) to allow greater access to this point of the room. Adjacent to southern blade of the truss a timber set in the wall and an uneven surface would suggest the presence of a blocked doorway (Plate 32). This doorway is roughly opposite the partly blocked doorway in the northern wall; however the two doors do not align completely.

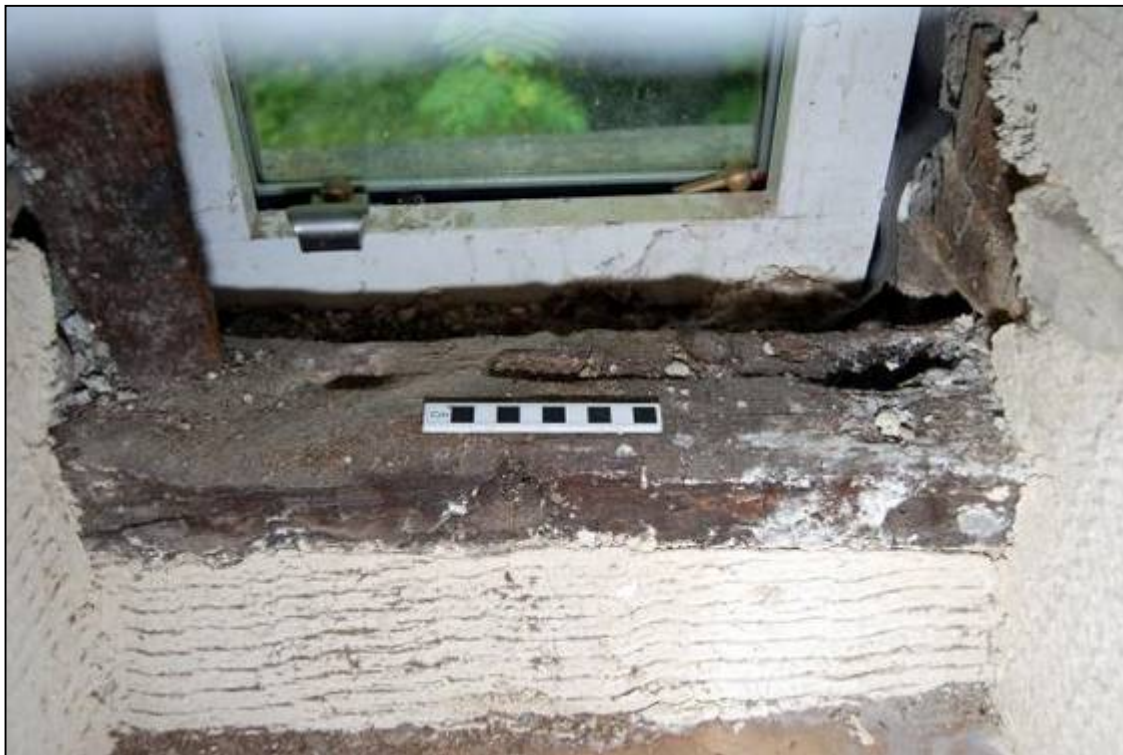
Plate 27: Sockets in the lower frame of the window in the SW corner of the lower western room

when the blades of Truss 2, now buried in the walls, were exposed and in the frame of the window in the south west corner of the building. Other observations made during the restoration of the house possibly hints that the gables of this timber phase may have been in stone (A. Brown *pers. comm.*), although it is also possible that the replacement of the timber framework was staged. The smoke blackening on Truss 2 would suggest that at this point the house was an open hall. The relatively steep angle of the truss may suggest that the building had an organic (such as thatch or turf) roof covering.

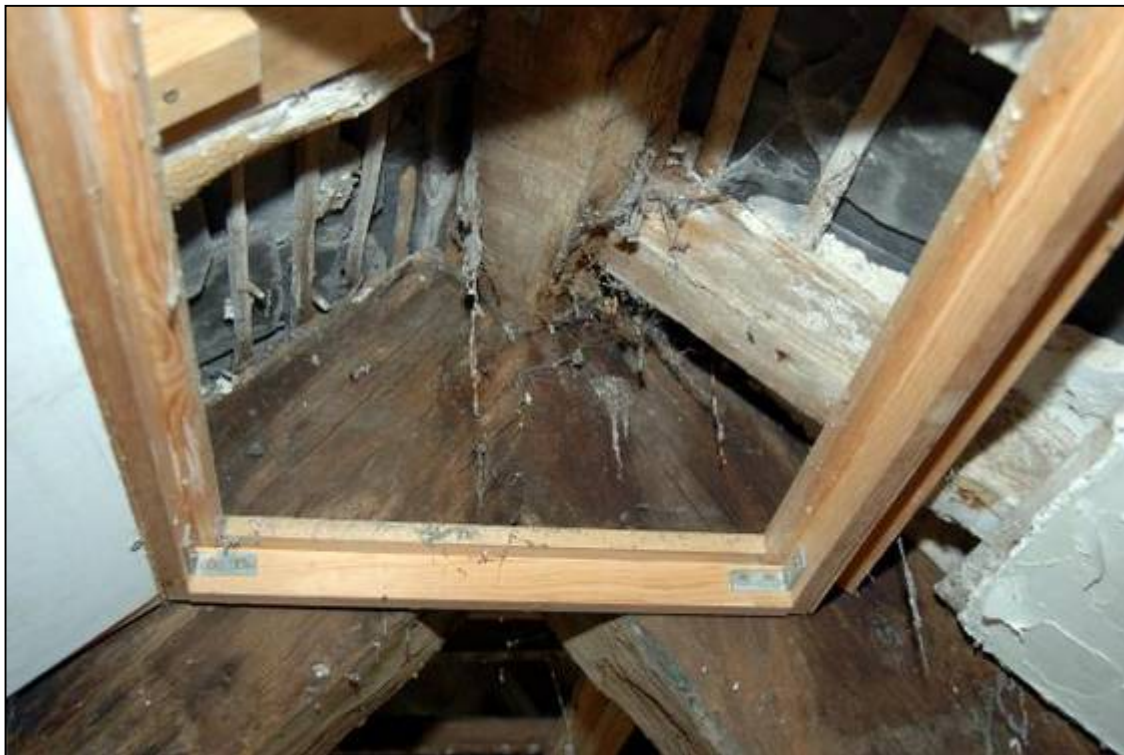
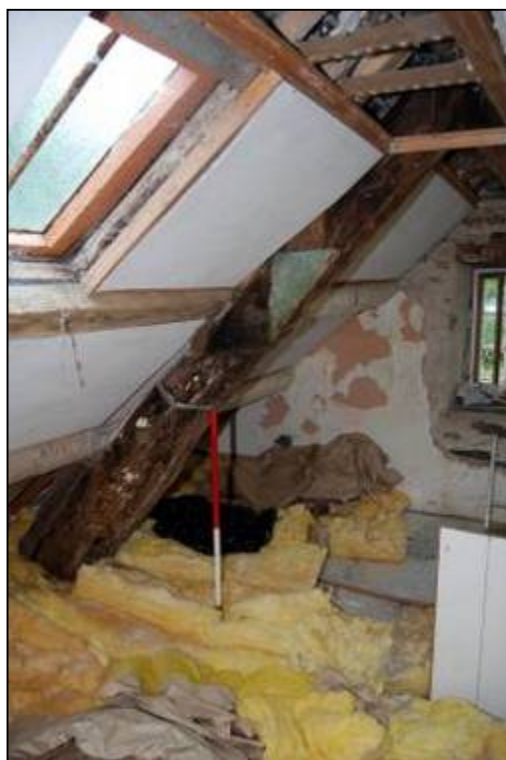
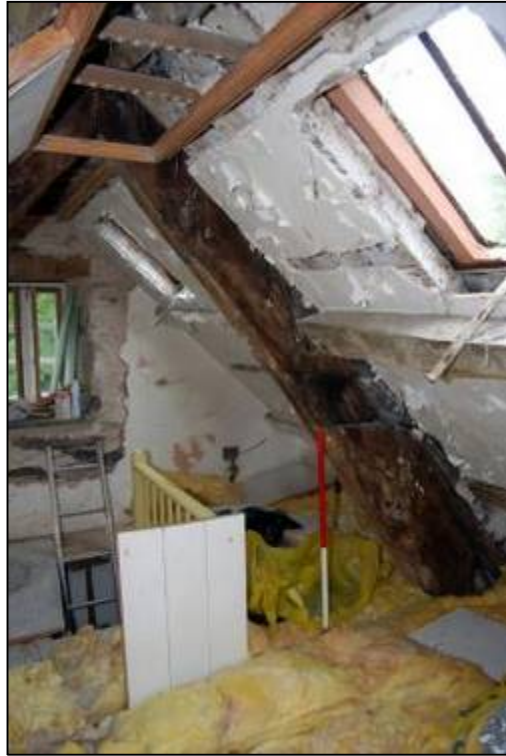
Plate 33: Peak of Truss 2

Plate 34: The southern blade of Truss 2

Plate 35: The northern blade of Truss 2

Truss 2 (Figure 6) is exposed in the attic above the western room (Plates 33 – 35). This is a cruck frame of Alcock's Type B (Alcock 1981, 95) with blades that meet on a vertical line, with a collar below the apex (Plate 33) and a ridge purlin in a trench. The collar for this truss has been removed; whilst the northern lap joint is straight (Plate 37) the southern joint is shaped (Plate 36). The upper purlins are still within trenches on the top surfaces of the principal rafters, however the lower purlins are associated with secondary rafters on the lower sections of the truss (Plates 38 and 39). The lower southern purlin is supported by a cleat, whilst the lower, northern purlin is trenched. The cruck frame is smoked blacked in places suggesting it may have been in an open "hall".

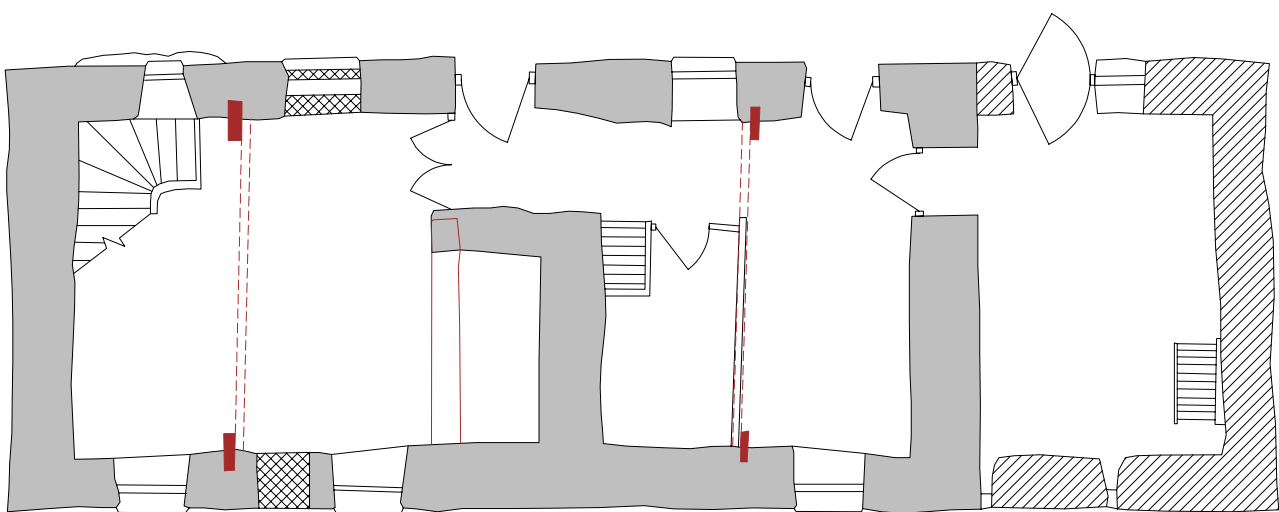
Figure 3: Plan  
Scale 1:100

Based on plans ByG/5 and ByG/6  
by Adam and Francis Voelcker  
July 1996

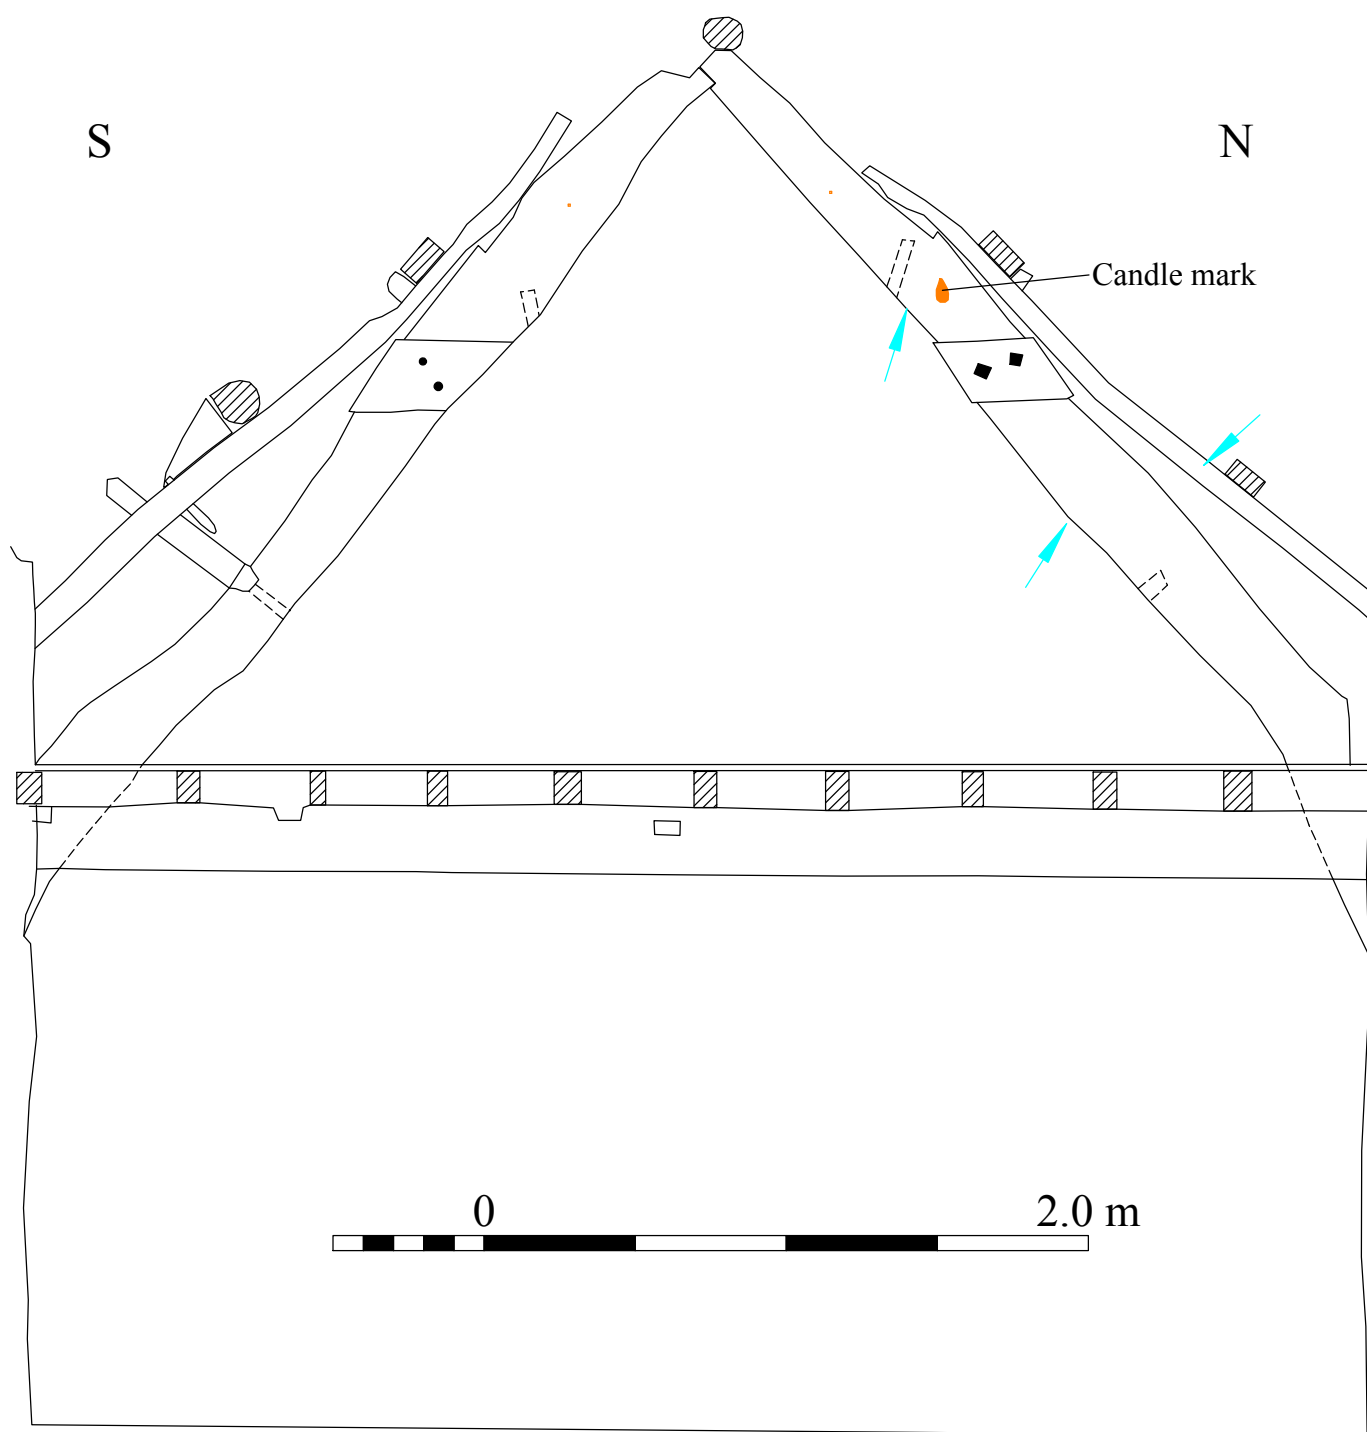
Figure 4: Truss 1  
Scale 1:25

⚡ Dendrochronological sample

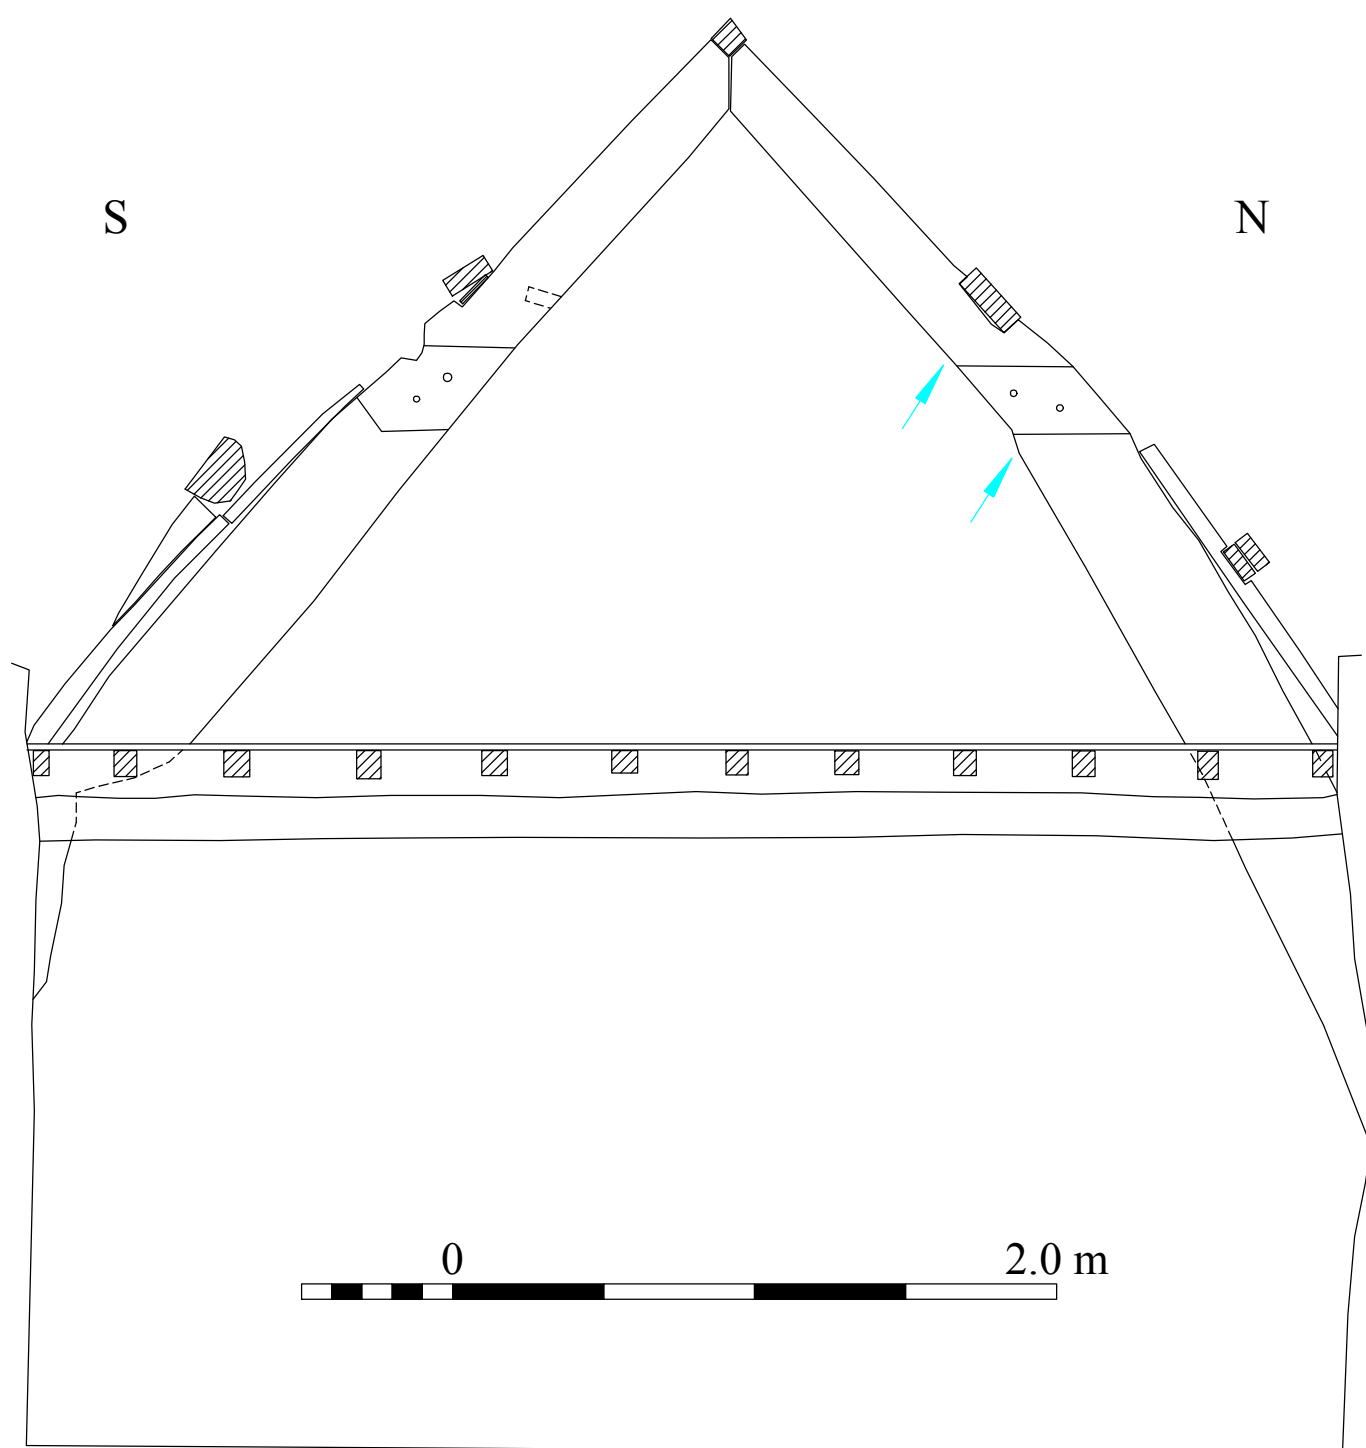
Figure 5: Truss 2  
Scale 1:25

Dendrochronological sample

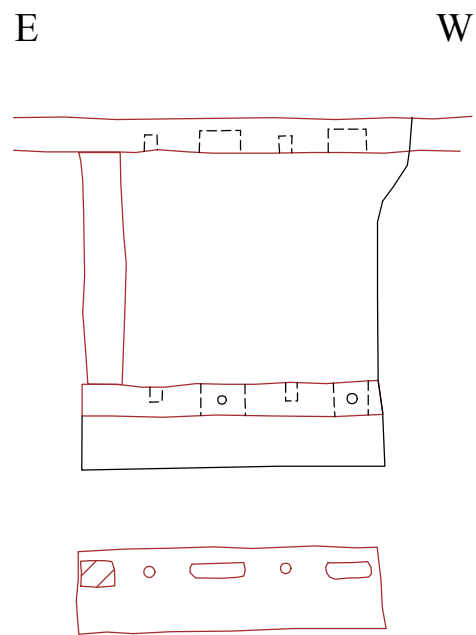
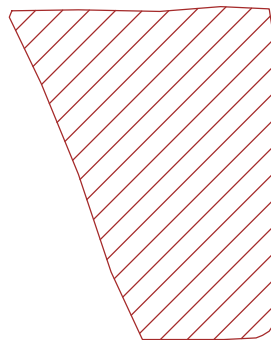
Figure 6: Other features  
Scale 1:10

Ground floor SW window

Section through bressumer
