**Bryn Dinas, Cwm Maethlon  
Desk Top Study and Building Survey**

***EAS Client report 2015/17***

**Bryn Dinas, Cwm Maethlon**  
**Desk Top Study and Building Survey**  
**Commissioned by**  
**Snowdonia National Park Authority**

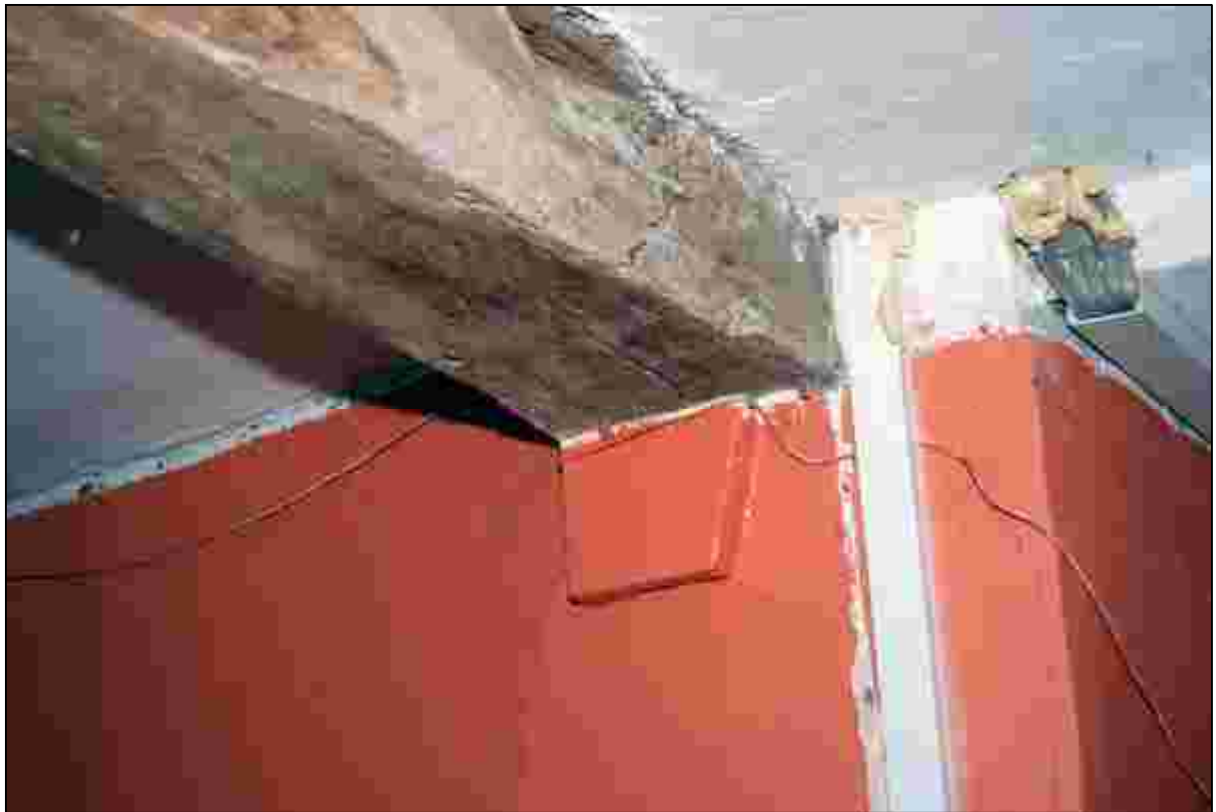
Plate 25: Chamfer and stop on the beam in the parlour

The chimney breast also protrudes into the parlour (Plate 24) within the space which is assumed to mark the original position of the cross passage. Whilst there is a ceiling beam crossing the parlour which is in the position where the western side of the cross passage would be expected this does not have any mortice slots nor dowel holes suggesting the position of the partition. This beam, however, appears to be a later replacement associated with a range of works which appear to have been carried out at this end of the house. The beam is slightly chamfered and has straight stops (Plate 25).

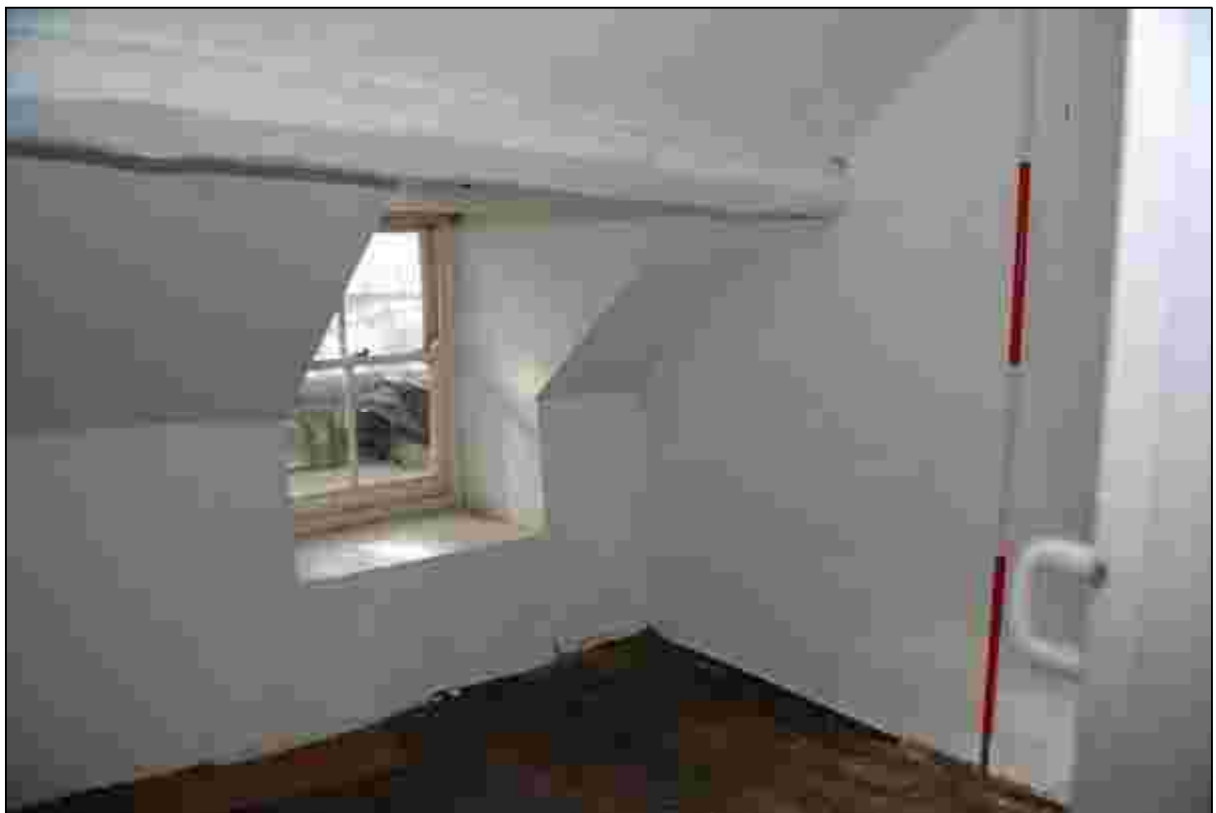
Plate 46: Bedroom 2

Truss 1 could not be traced in the eastern wall of Bedroom 2 and there are few architectural features in this room. The exception is the exposed purlin (Plate 46) on the southern side of the room, which would appear to be a later replacement as it has a much less square profile than the purlin with the slot for a windbrace in the landing. This purlin continues into Bedroom 3 (Plate 47) where there is a modern inscription from Psalm 103, verse 8 in felt tip marker on the purlin (Plate 48). Bedroom 3 runs along the southern side of the chimney stack and there is a shelf at a height of about 0.8 m above the floor possibly suggesting the stack is stepped at this height. Above the door to this room fragments of an earlier decorative scheme are preserved (Plate 49) with fragments of a wallpaper with a floral pattern survives.

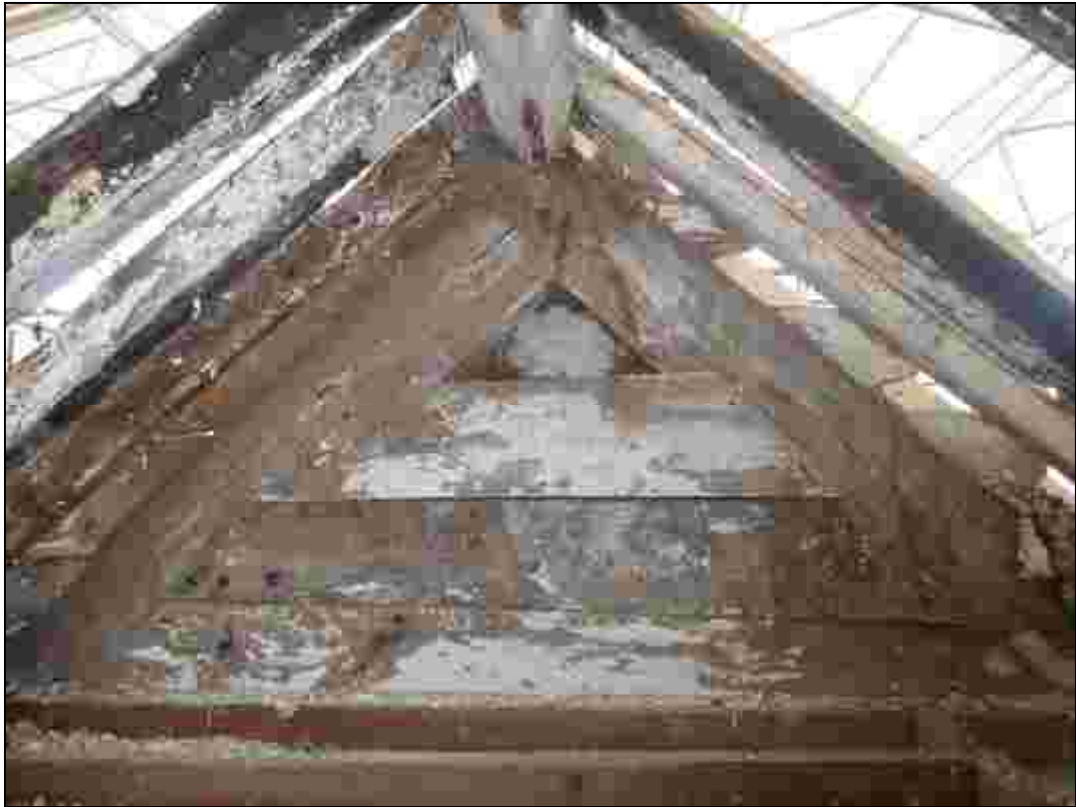
Plate 69: Top of Truss 1

The works to the roof has allowed more detailed to be recorded to the trusses. The top of Truss 1 (Plate 69, Figure 13) was revealed by damage to the ceiling on the landing by falling slates when the roof was stripped. The principal rafters are noticeably lighter than those used for the other trusses, possibly suggesting that this truss has been replaced. The principal rafters are joined with a lap joint held with wooden pegs and the northern principal rafter is treenched to hold the ridge piece. There is also a collar, at ceiling level, linking the principal rafters. The eastern side of the truss has two planks nailed to it, probably suggesting that the partition below this truss was in existence prior to the additions of the ceilings in the early twentieth century.

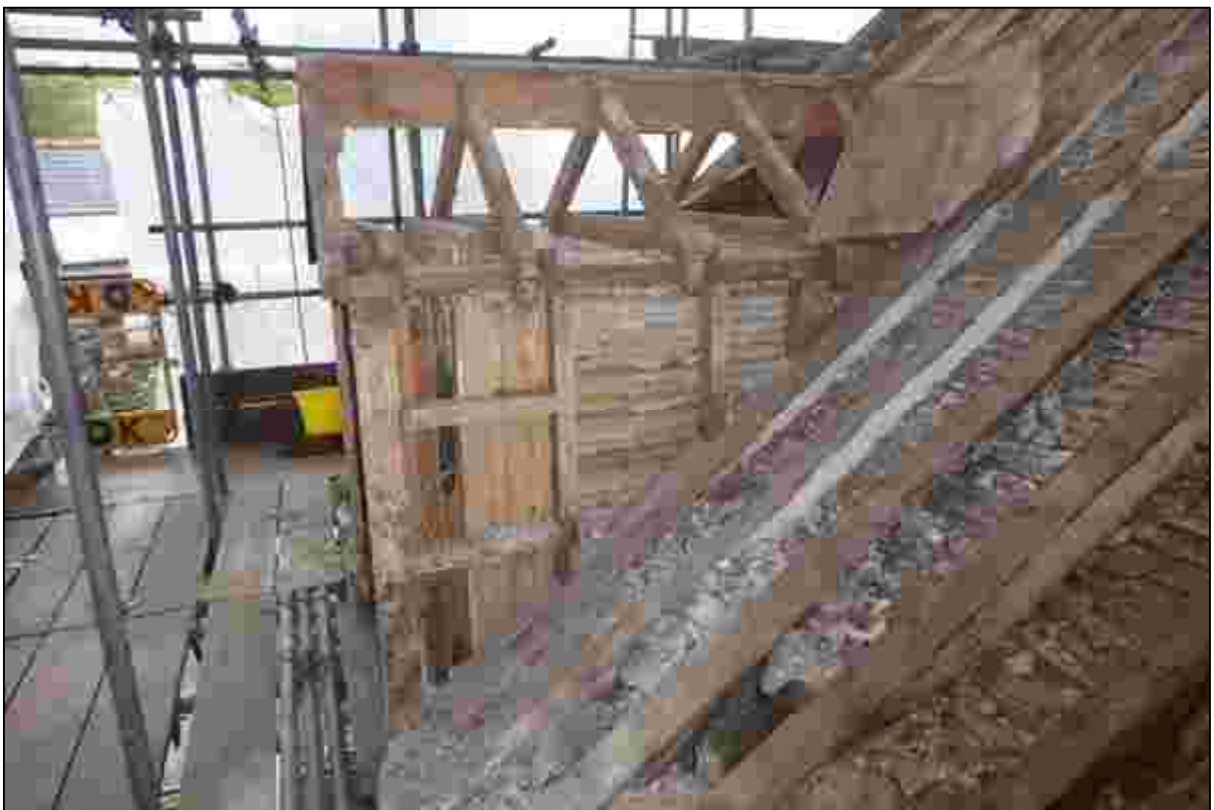
Plate 82: Structure of the dormers

The dormers on the southern side of the house appear to be relatively modern additions/replacements constructed of relatively light, sawn timber (Plate 82). Indeed a paper label (Plate 83) attached to the frame for the sash window in the western dormer reads:

This would suggest that the dormers were constructed, or at least replaced sometime after 1938.

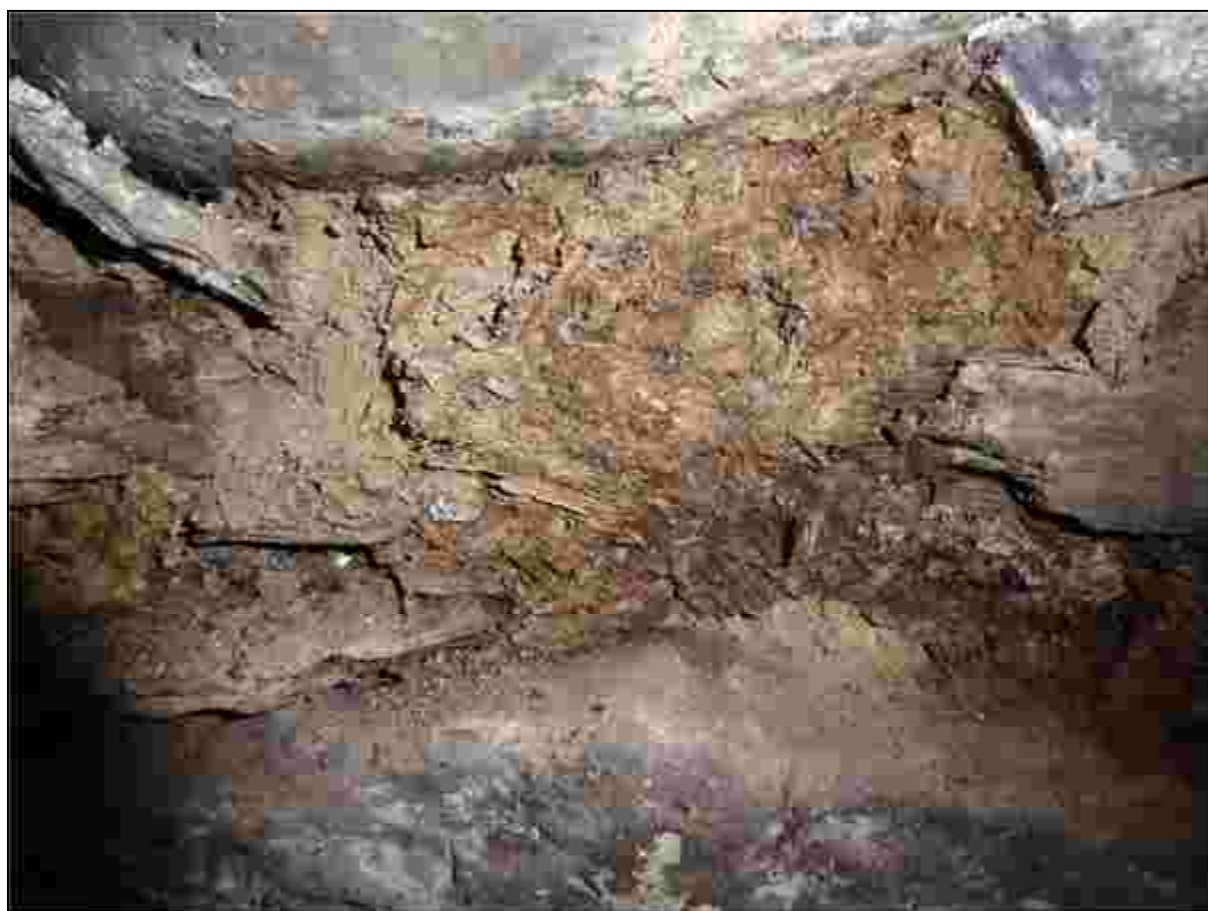
Plate 92: Detail of the earth bonding in the wall near the southern blade of Truss 3

The investigation of the condition of Truss 3 demonstrated that the blades of the cruck frame extend further into the walls of the house (Plates 90 and 91), demonstrating the original timber framing of the house. The work also revealed the daub used as mortar in the wall at this point (Plate 92).

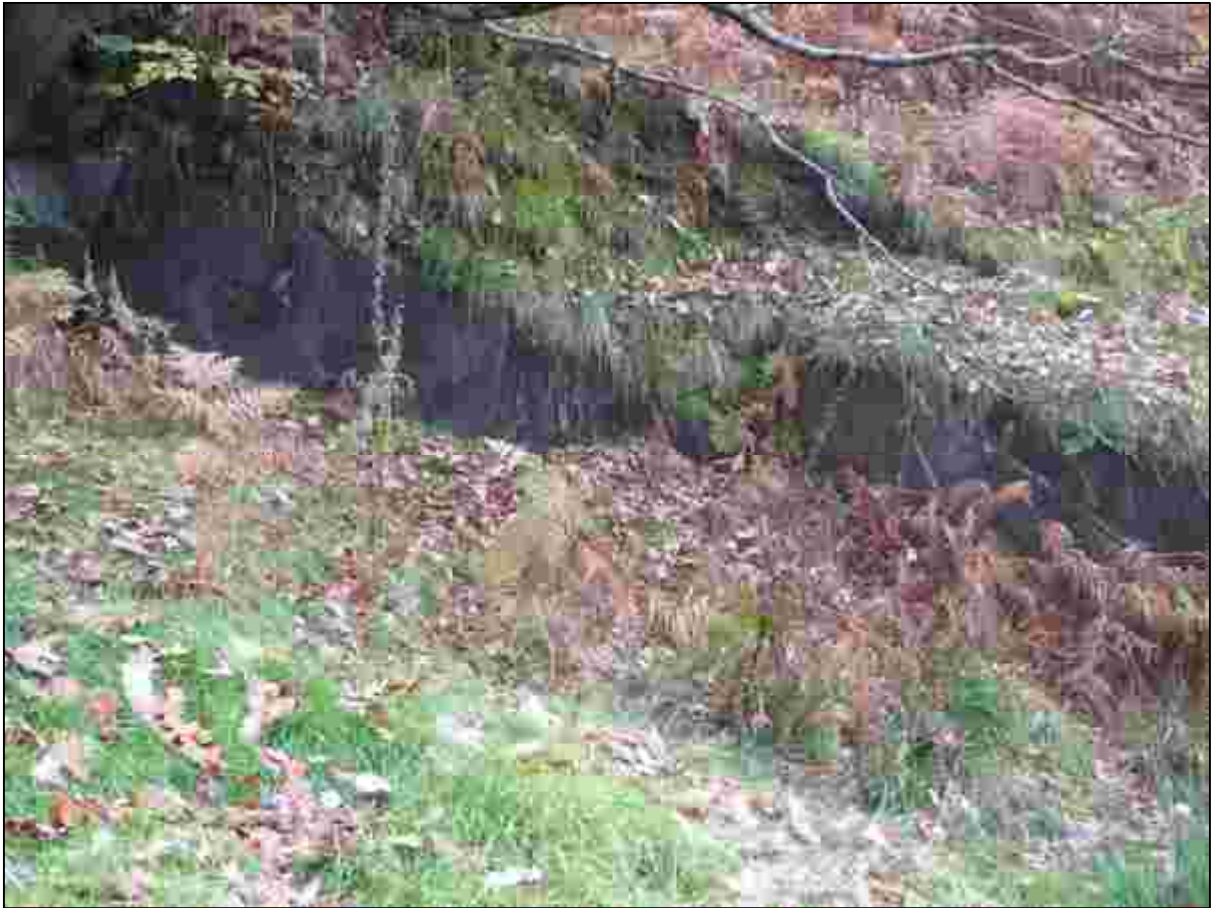
Plate 93: Small quarry, possible source of the moss slates

This would appear to be part of a major investment in the farm at this period with the construction of the barn and possibly other farm buildings. The finance for this investment is likely to be related to the exploitation of the lead deposits in the area. In rural Wales even within what became the major slate-producing areas slate roofs only spread below the social level of an *uchelwr* in the sixteenth century. (Gwyn 2015, 30), thus it is likely that it is within this phase of activity that a previously thatched roof was replaced with moss slates. It is likely that the slates were quarried locally, indeed a series of small quarries (Plate 93) were located alongside the track to the house which may have served as the source for the slates.
